The
Journal
of the
Norfolk Industrial
Archaeology Society
Volume 9, No. 3

MALTINGS, MUNDESLEY ROAD, NORTH WALSHAM

Report by Derek Manning and Graham Smith.

BEATING CHAMBER, 50 PIER PLAIN, GORLESTON

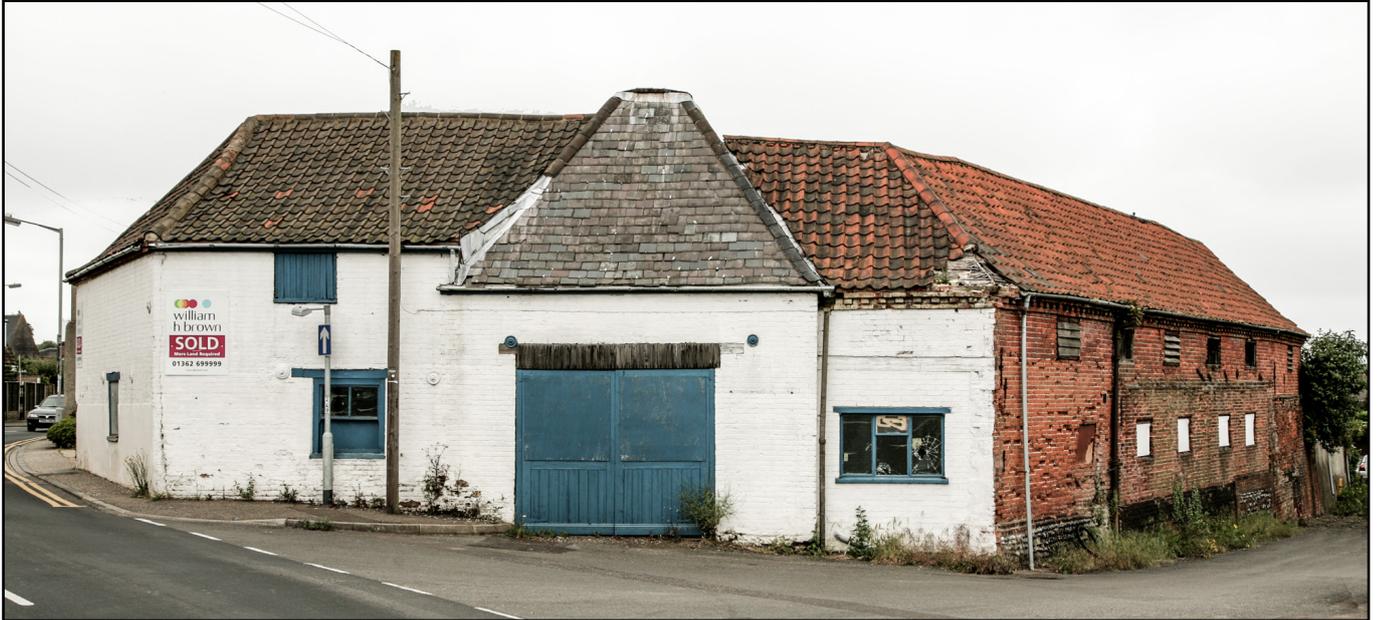
P1 General view of Maltings from the east, showing N elevation of maltings and E elevation of kiln buildings.

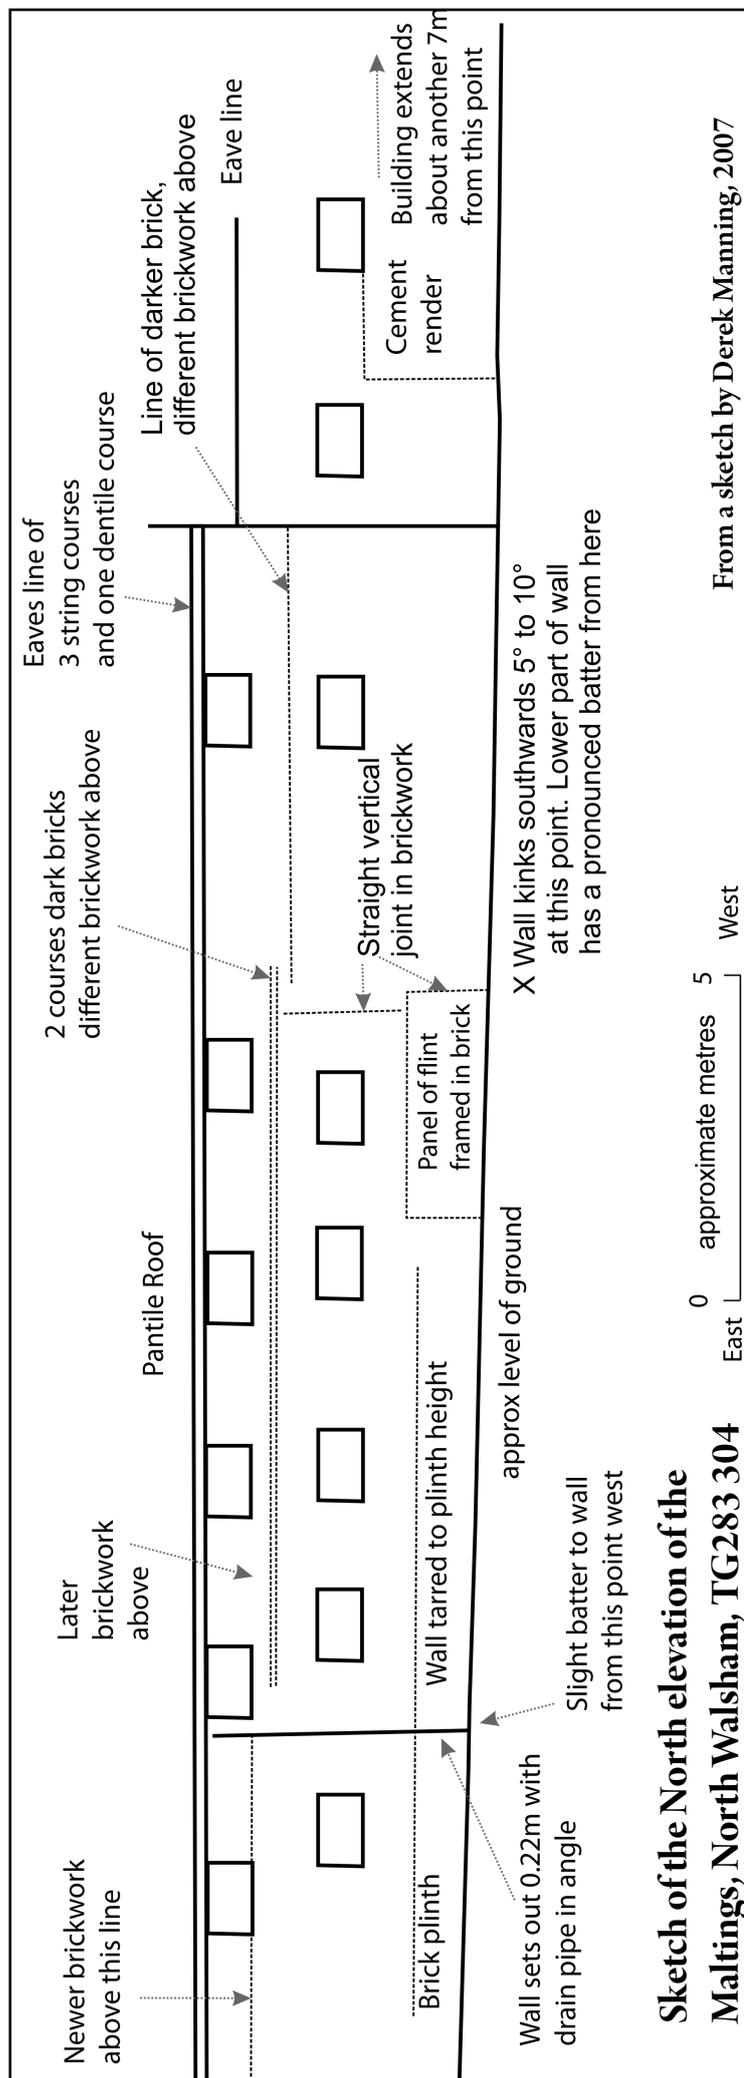
Sketch of the North elevation of the Maltings, North Walsham, TG283 304

From a sketch by Derek Manning, 2007

a. The North Elevation of the Malting Block

The overall length of this elevation was about 36 metres, and appears to have been built in several sections, the ground level falling to the west along the length of the elevation. Starting at the east end, the first section, extending to about 5.5 metres, had a flint plinth and was built in English bond brickwork for the first four to five courses with mixed up English bond above. On top of the plinth, which projected slightly from the line of the wall, were three courses of chamfered bricks. Above these were twelve courses of brickwork to the sill of a window ten courses deep; above this opening there were fifteen courses to the sill of a higher louvred opening nine courses deep. These courses were of a different quality from those below and indicate that the wall had been heightened. There was then a slightly projecting string course with a course of ventilated bricks above it. A further string course formed the eaves level. The roof was clad with Norfolk pantiles. The top, later, section of brickwork was also evident on the first section of the return to the east elevation, as was the decorative treatment of the eaves level, but this stopped at the junction with the malt kiln.

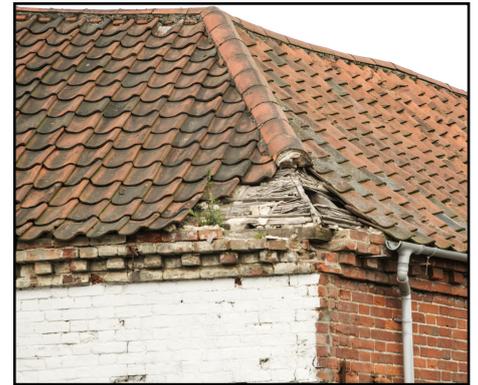
P2 - Top left: Maltings North Elevation from east

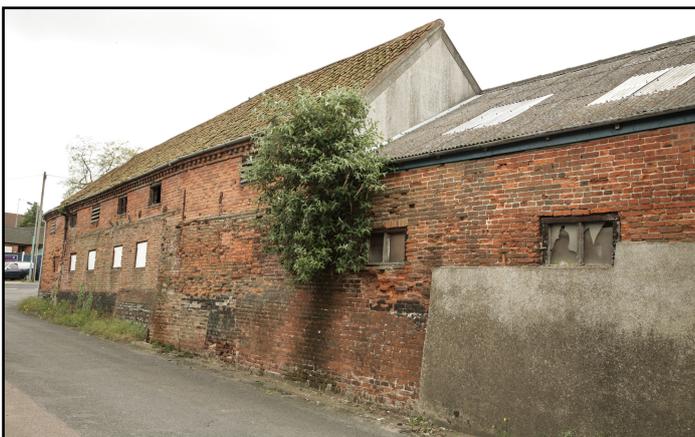
P3 - Top Right: Detail of roof and dentile brick course

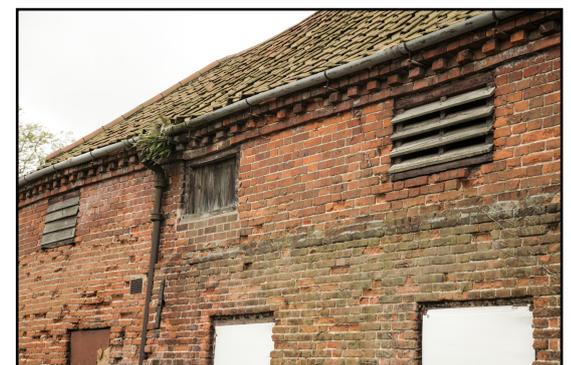
P6 - Left: West end of North elevation

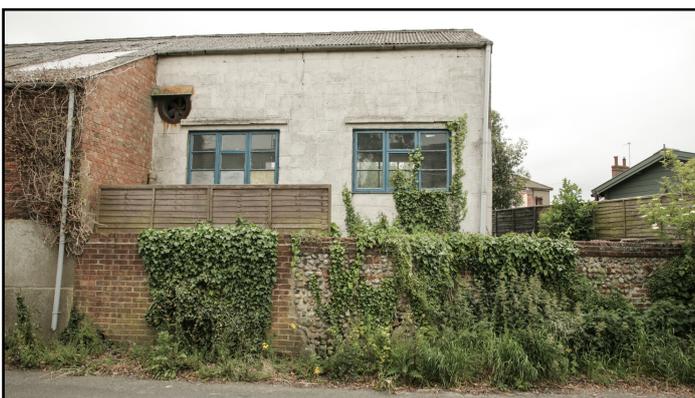
P9 - Left: West most building from North

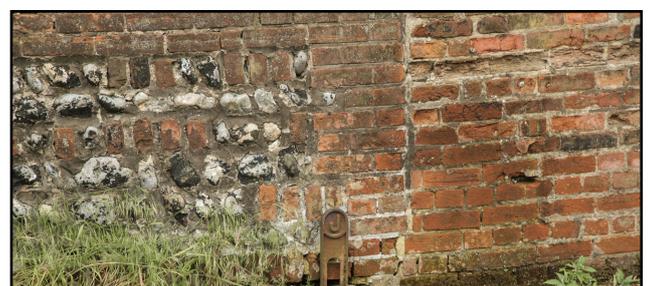
P10 - Detail of plinth wall and brickwork changes

The next 3.5 metres of the wall was the same as the previous section except for a flint and brick plinth re-occurring. This plinth had brick quoins at each end and was six brick courses along the top, the top course being chamfered. Above this plinth the brickwork was a continuation of the previous section but stopped about 0.3 metres short of the west end of the plinth. At this point there was a straight vertical joint in the brickwork between this section and the next section to the west. There were straight mortar joints at each end of the plinth. The third section of the elevation kinked to the south compared with the previous sections and had a more pronounced batter at low level. The brickwork was more heavily weathered than the previous walling. It had no plinth but there was a course of darker bricks about 42 courses from ground level, which in turn was five courses below the darker course in the previous section to the east. Above this, the brickwork matched that of the previous sections of the elevation. There had been major repair of the lower brickwork at the west end.

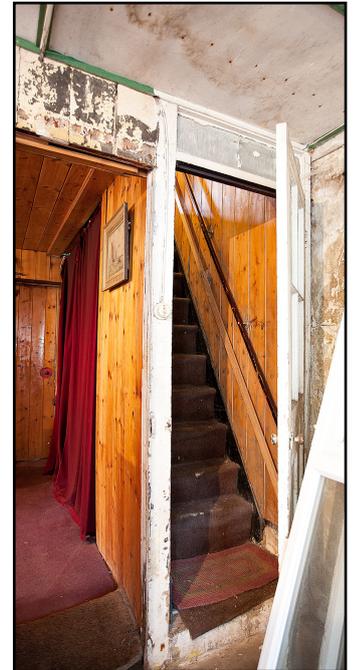
Detail of stair and entrance to modern kitchen area

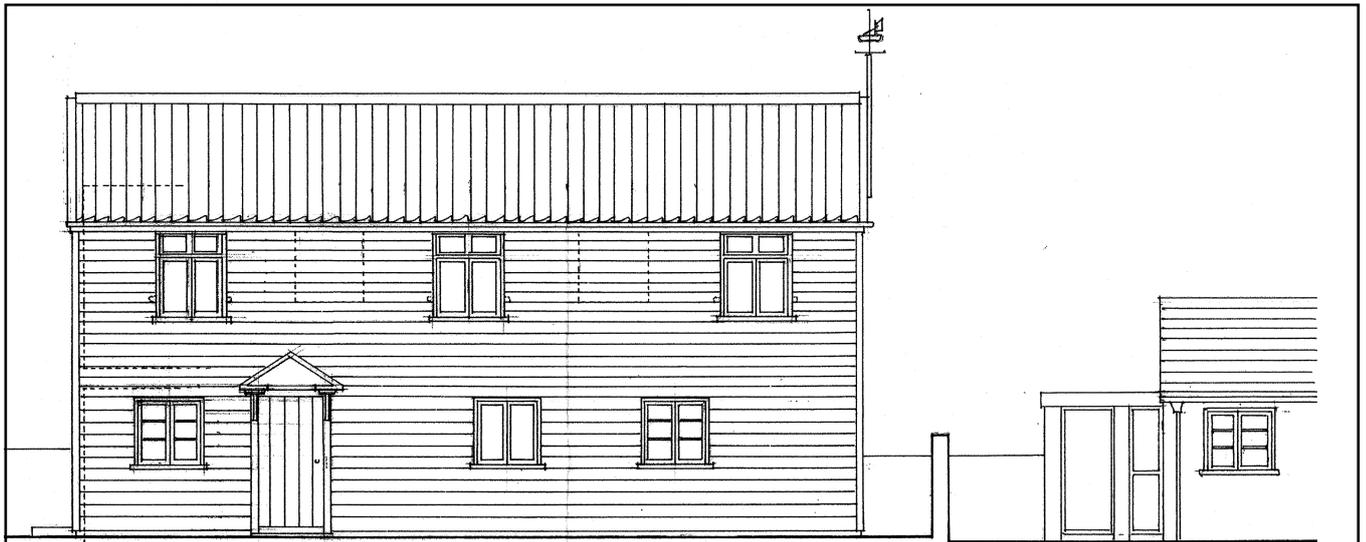
South Elevation

Top: as is now

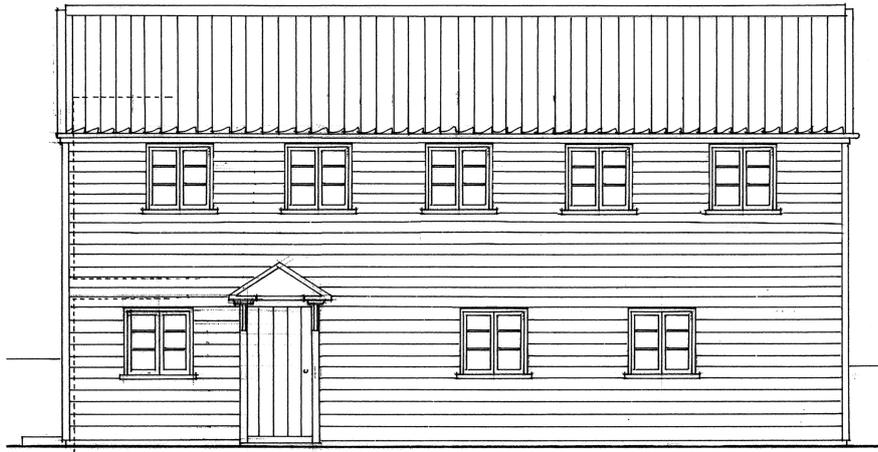
Left: Reconstruction of original window layout.

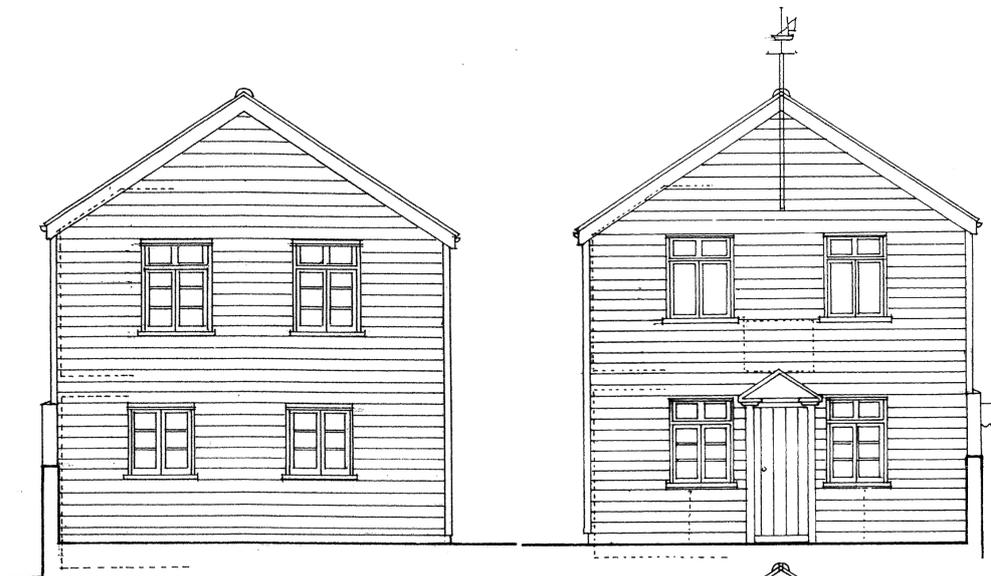
End Elevations

Above: West and east elevations

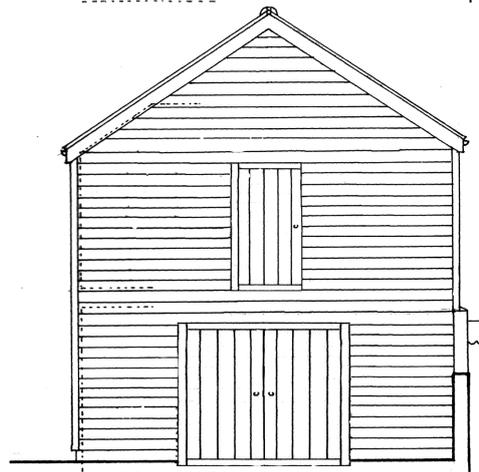
Right: Reconstruction of original east elevation layout.

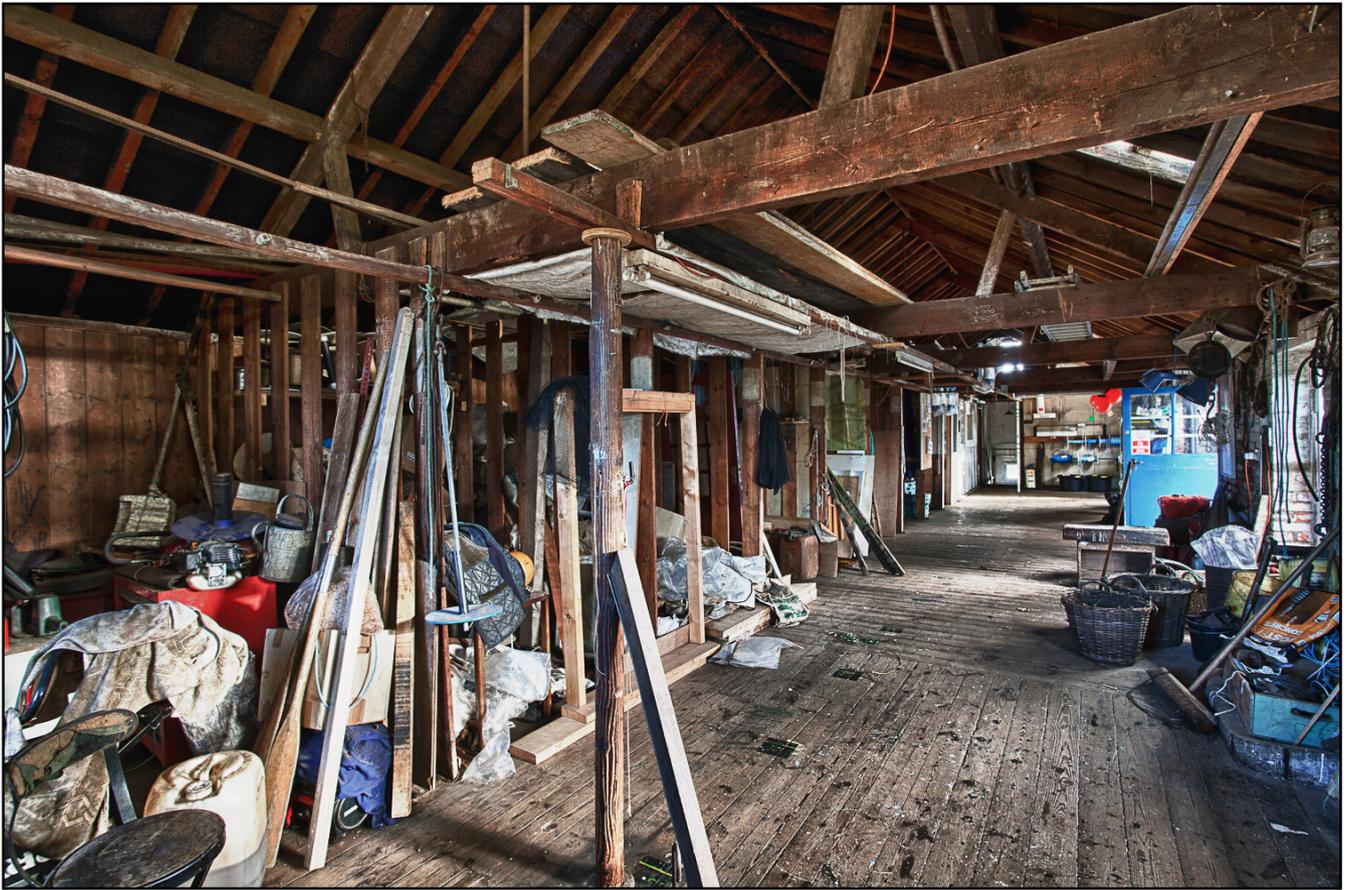
Above: General view down the interior of the first floor, showing the boarded rear wall, partitions and posts for net construction, as well as goods relating to the chandlery.

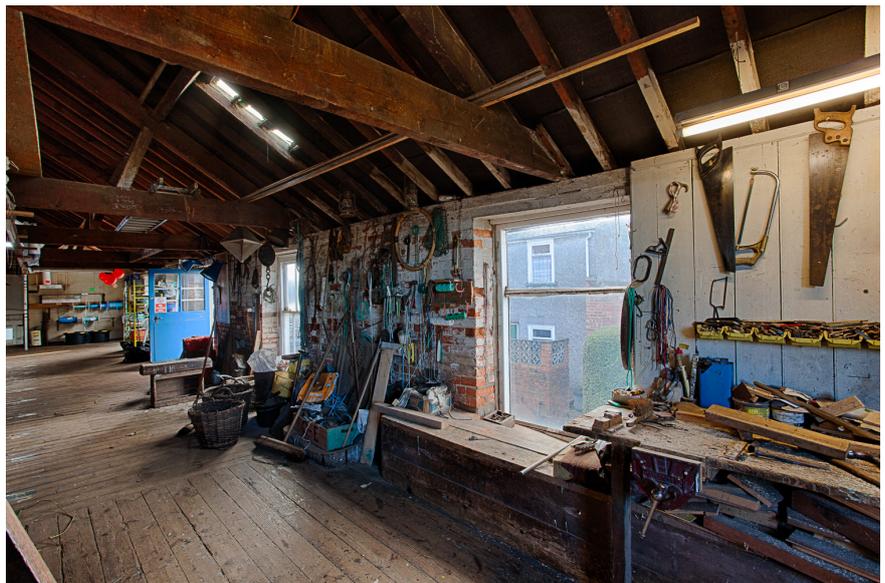
Right: general view along the south wall of the first floor interior.

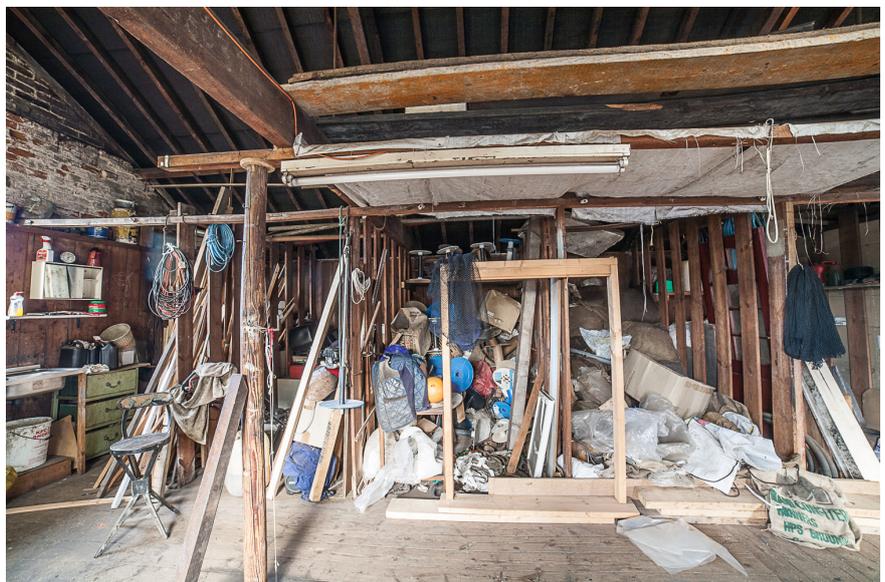
Left: view of partions at the west end of the first floor interior.
